Fast Regeneration
Restored Motion

Table of Contents

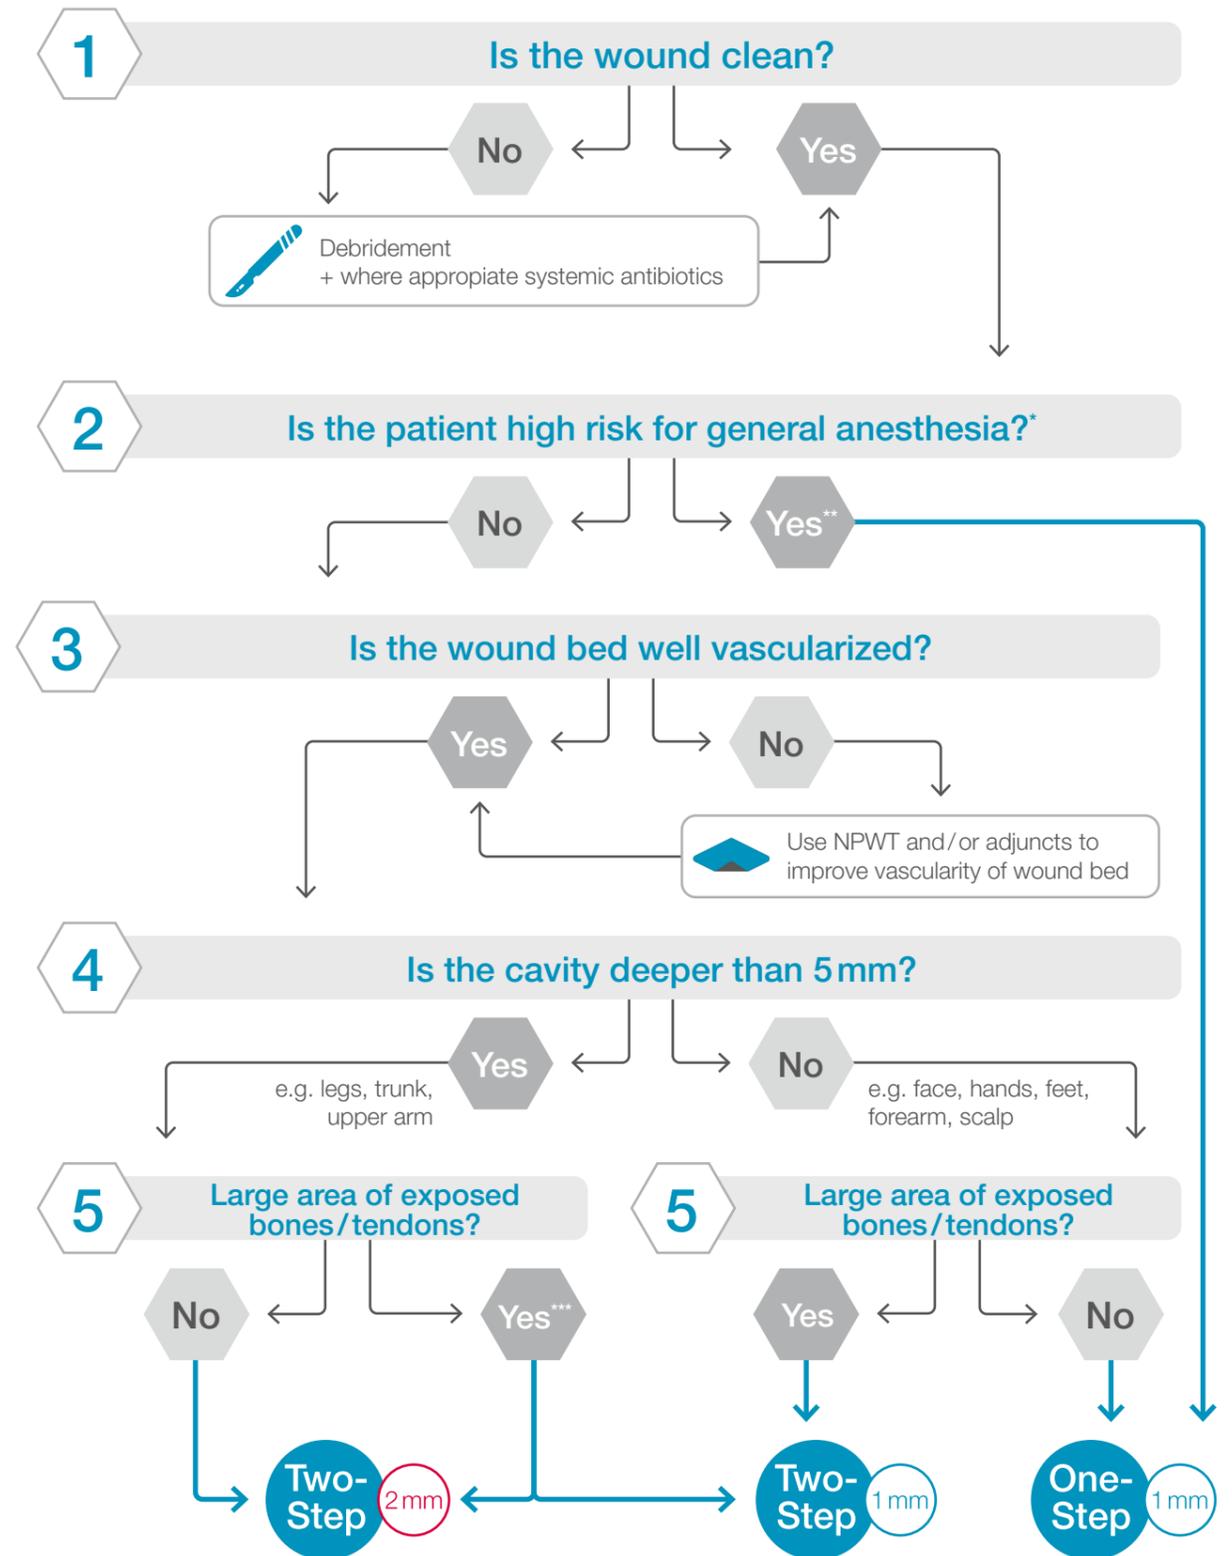
* This applies for both local and general anesthesia
 ** Irrespective of depth of cavity and degree of exposed bones/tendons
 *** Depending on surgeon's experience and patient factors

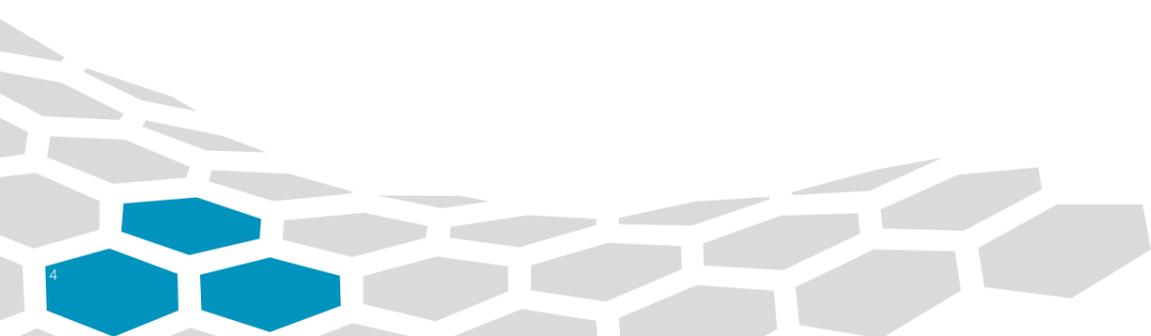
Hand scar revision after burn

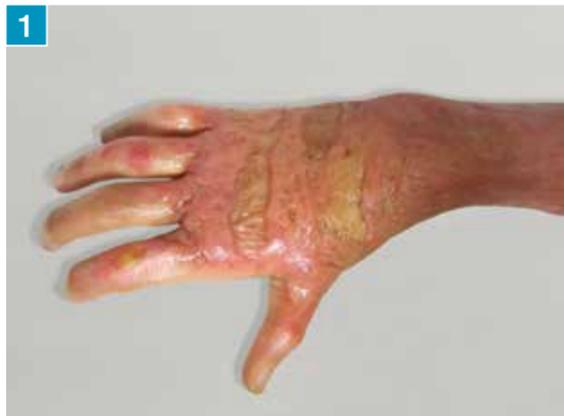
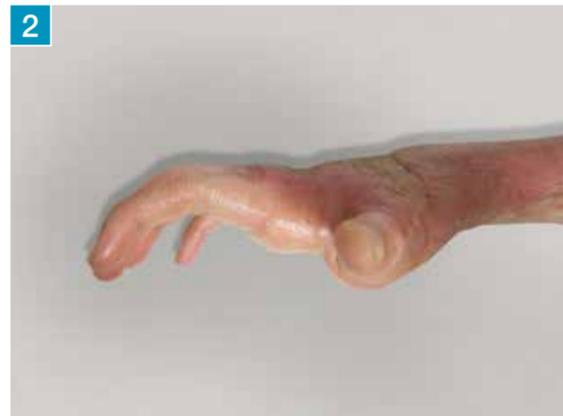
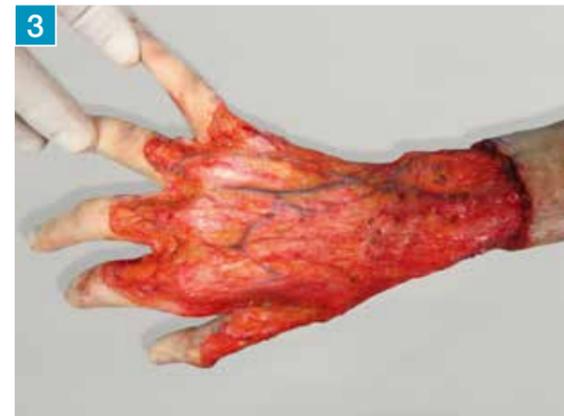
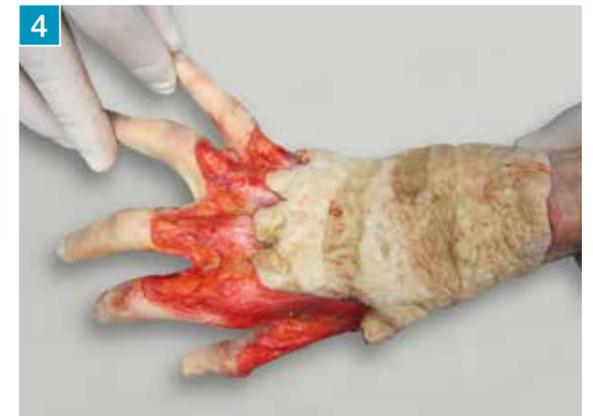
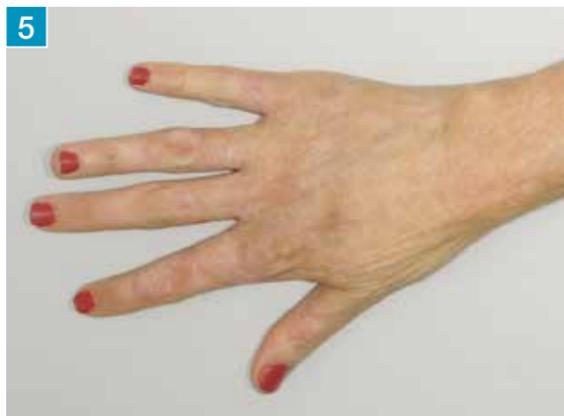
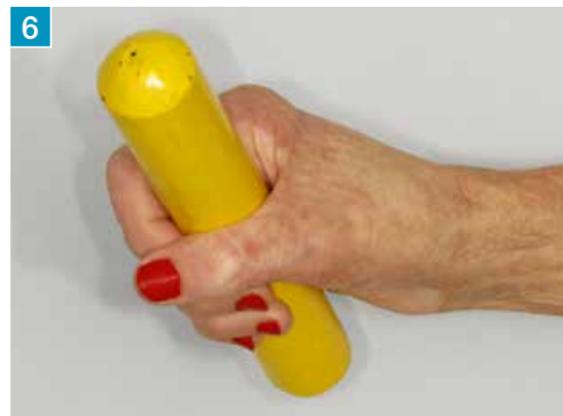
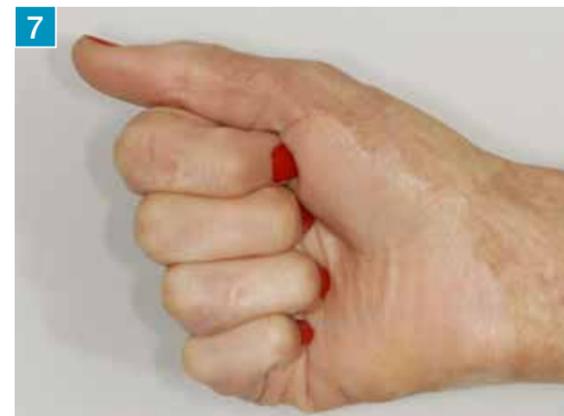
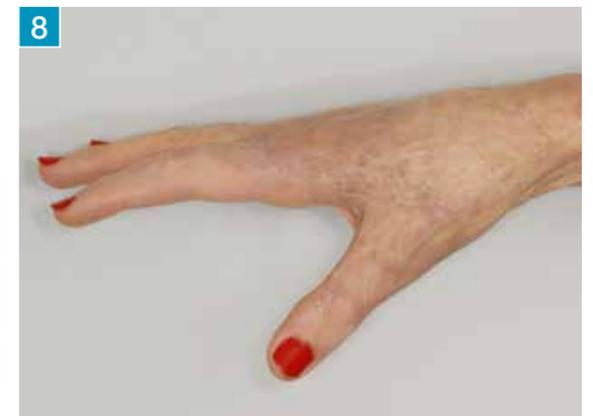
Pediatric scald burn

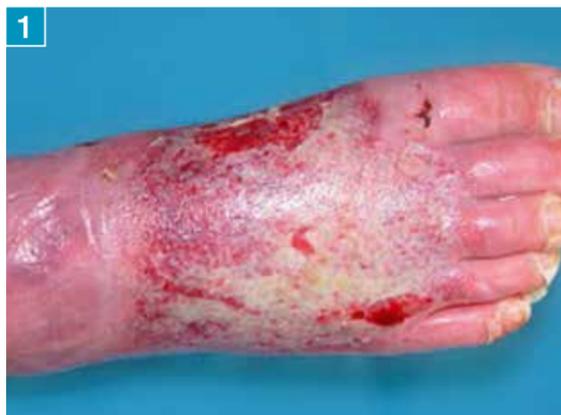
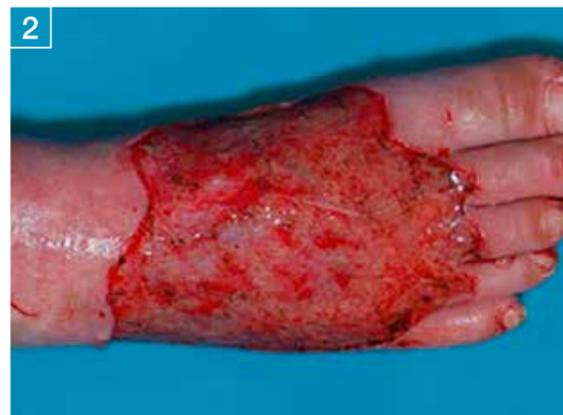
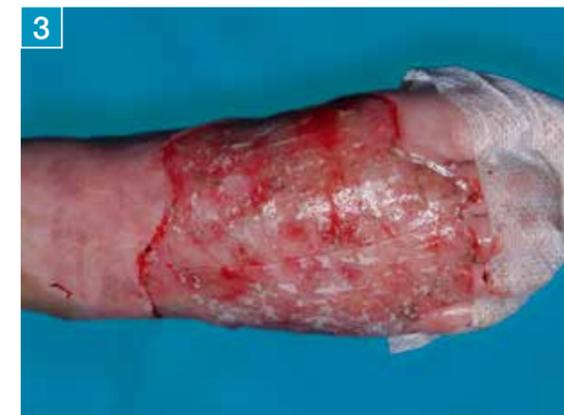
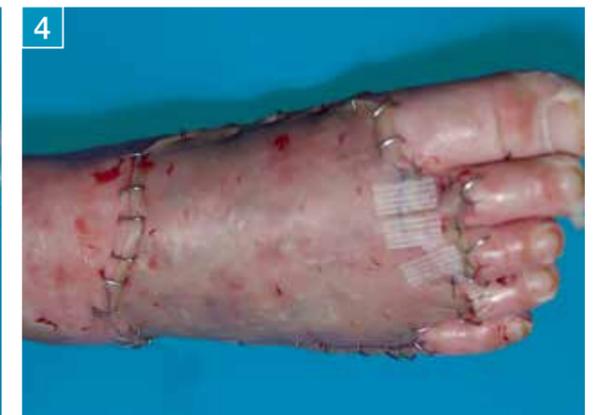
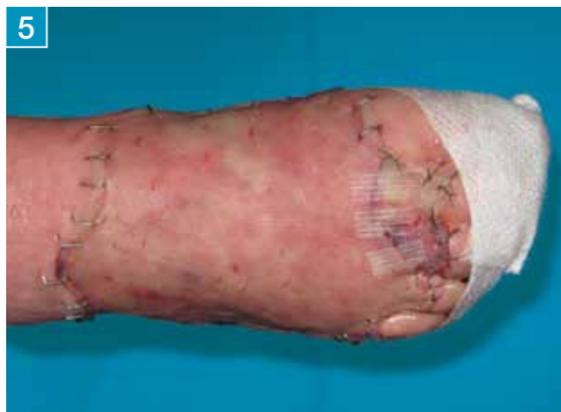
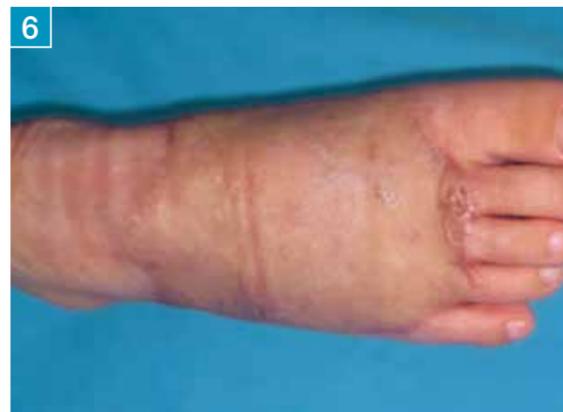
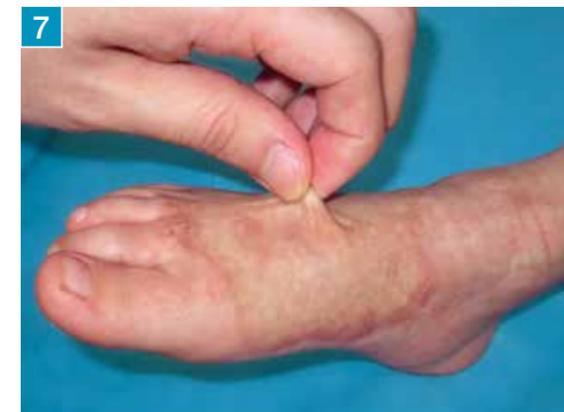
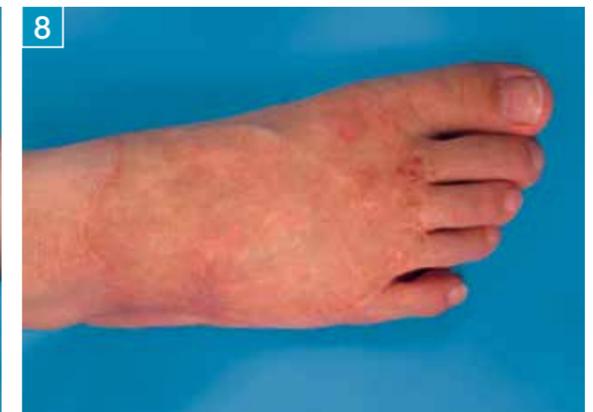
Massive scar contracture on flank

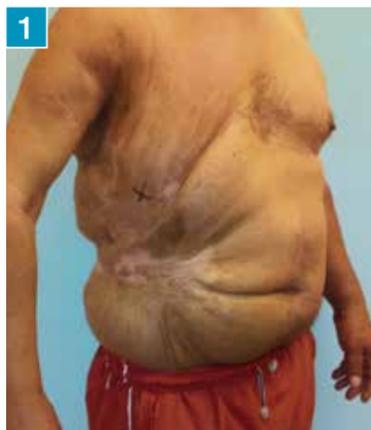
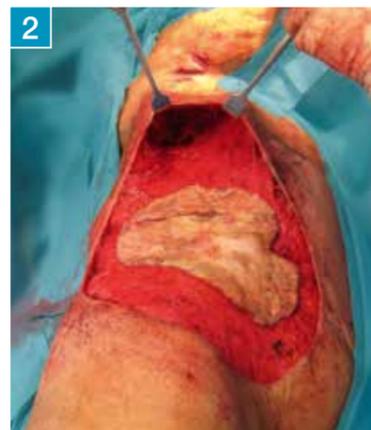
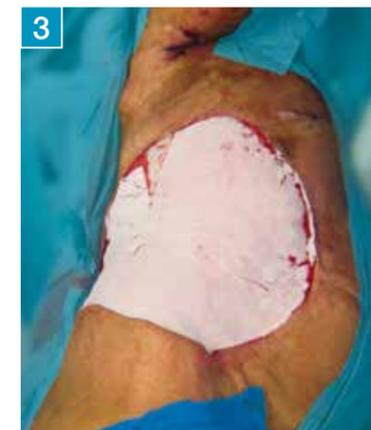
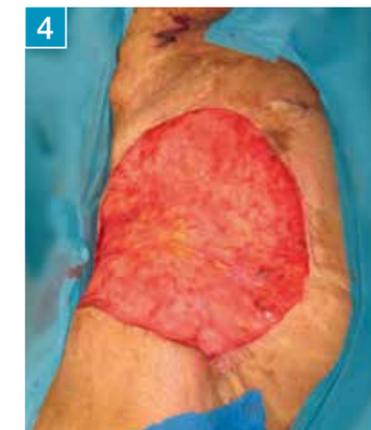
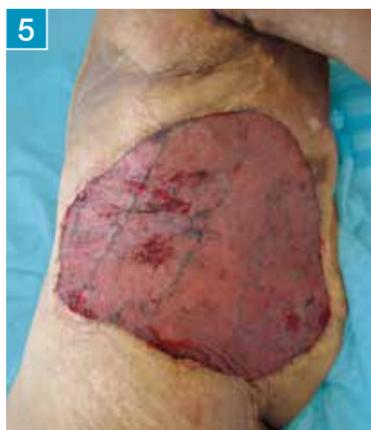
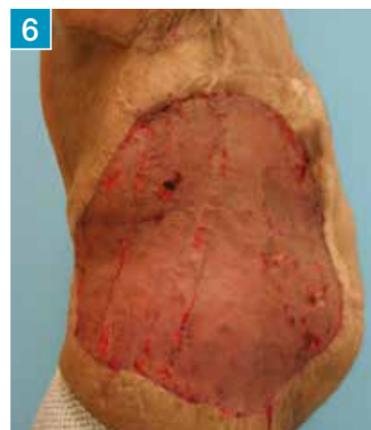
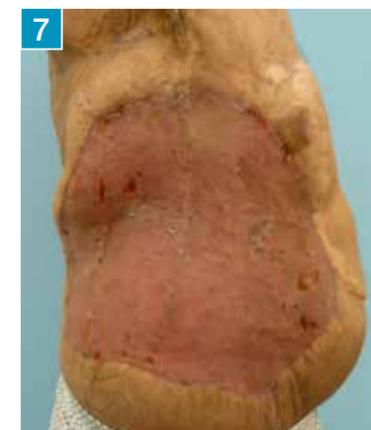
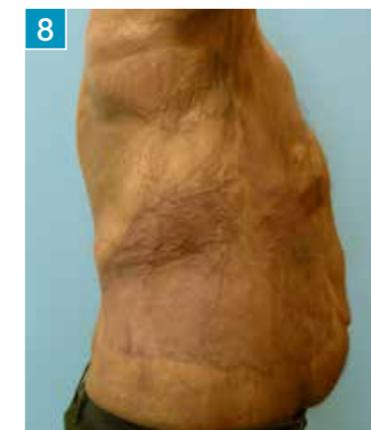
Revision surgery of burn scar at the lower limb

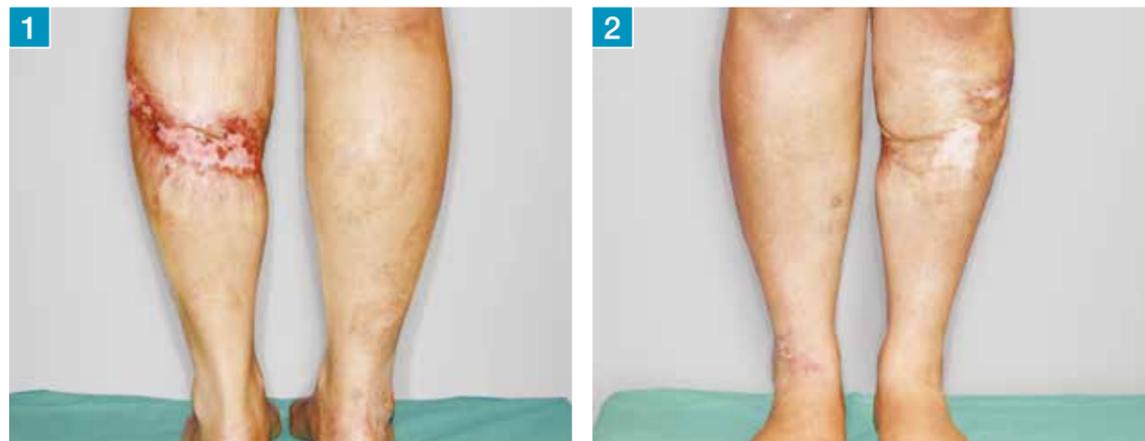
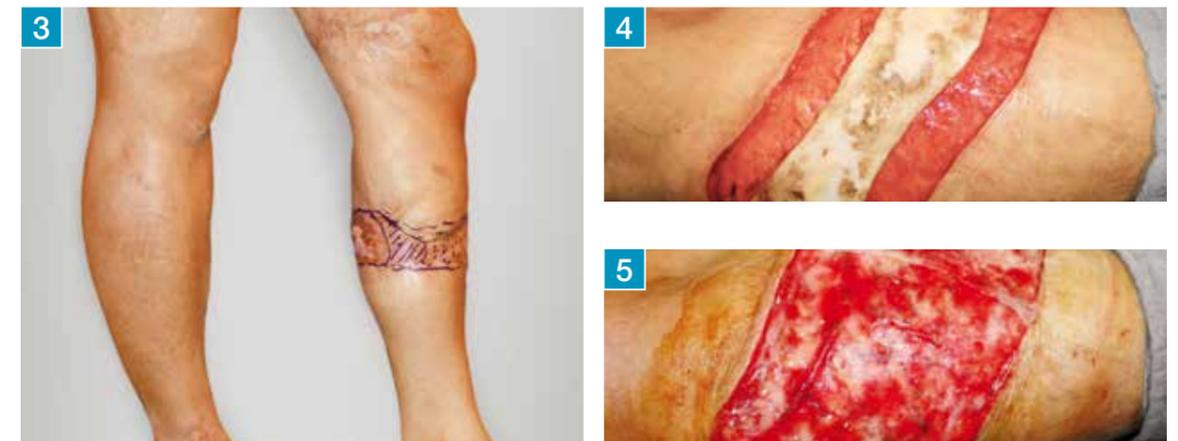
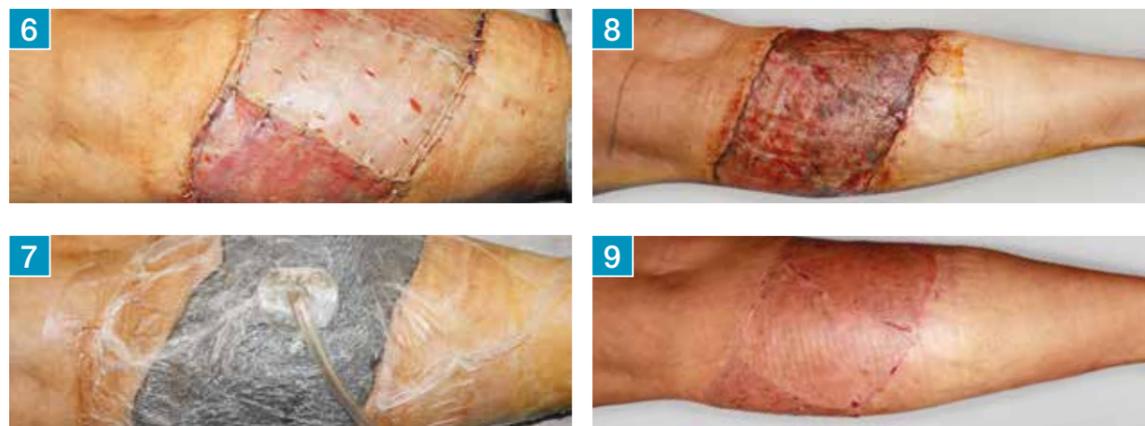
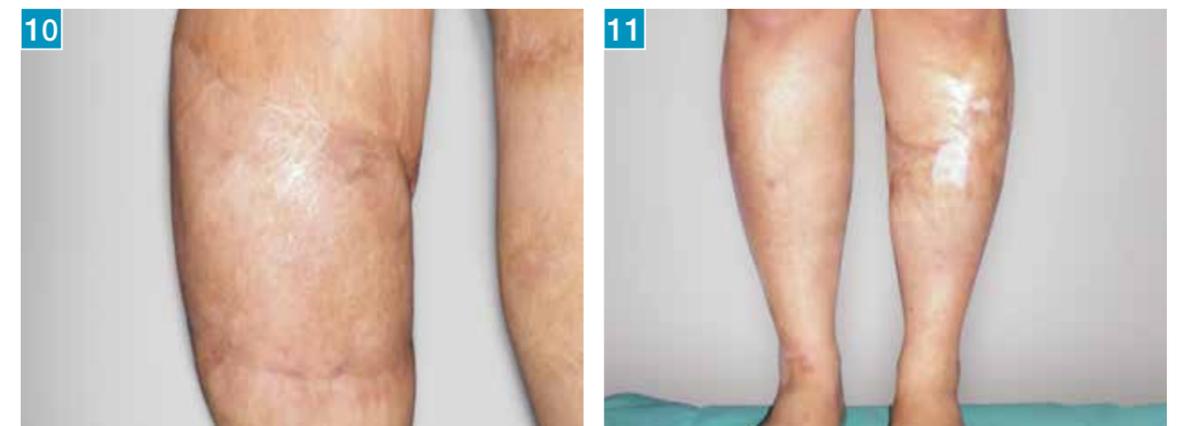
Flame burn on chest and neck

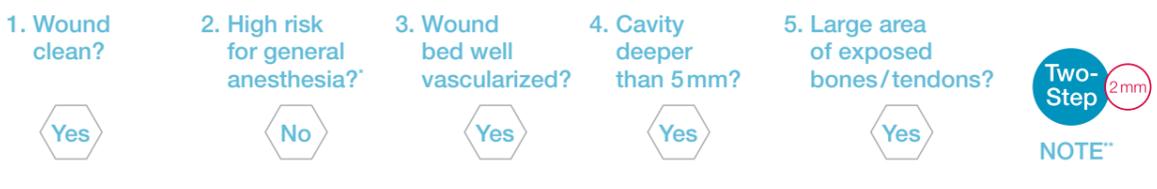
saline (Fig. 4), immediately followed by placement of a meshed split-thickness skin graft on top of MatriDerm® in a One-Step Procedure (Fig. 5). Negative pressure wound therapy was initiated post-surgery. At the follow-up visit three weeks later, stable wound closure with complete integration of the skin graft was observed (Fig. 6, 7). The patient had good initial mobility of his elbow and wrist. Five months later the patient was back at work.

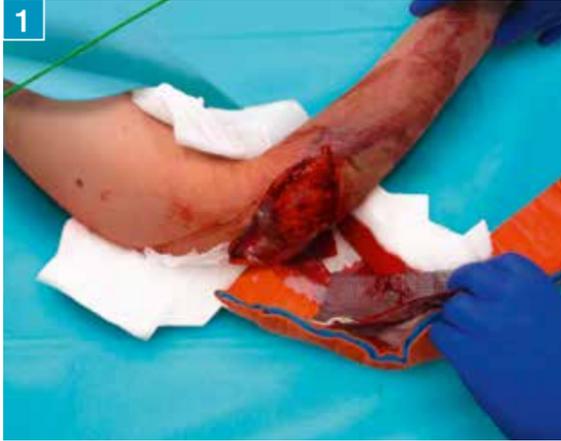
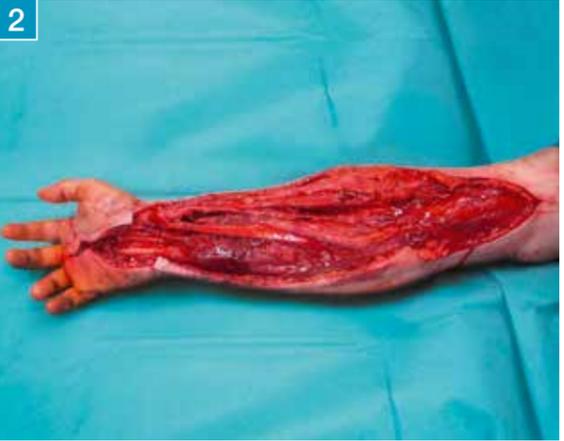
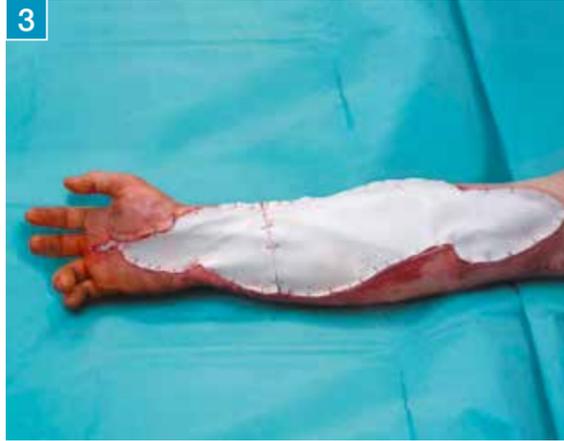
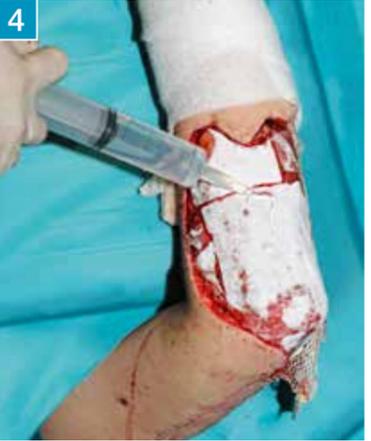
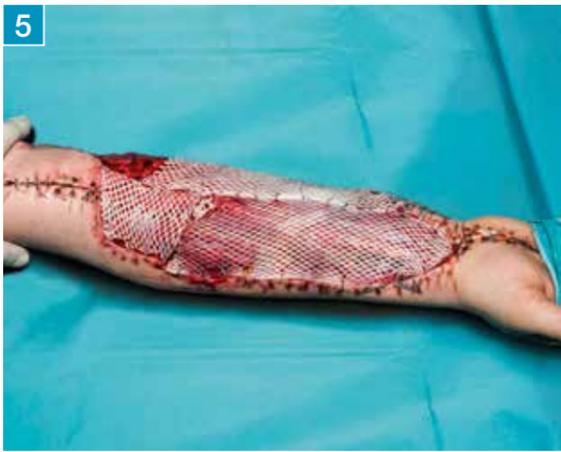
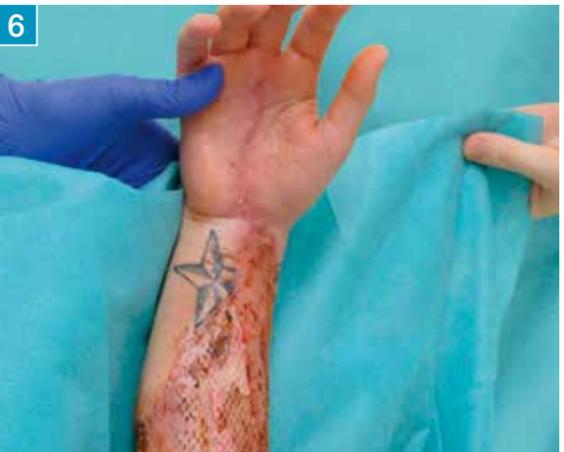
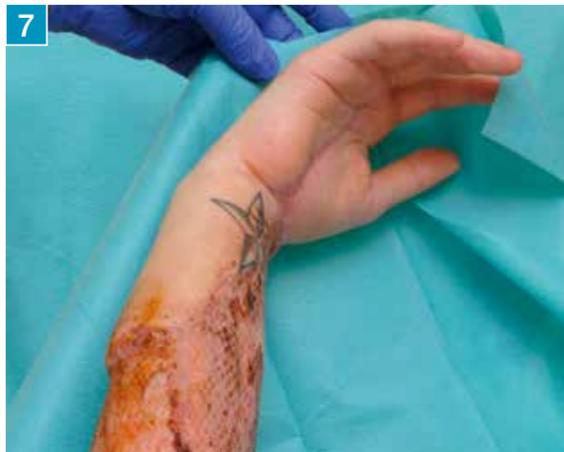
* Courtesy of M. Kerl, MD, Graz, Austria
 Epigard by Biovision GmbH

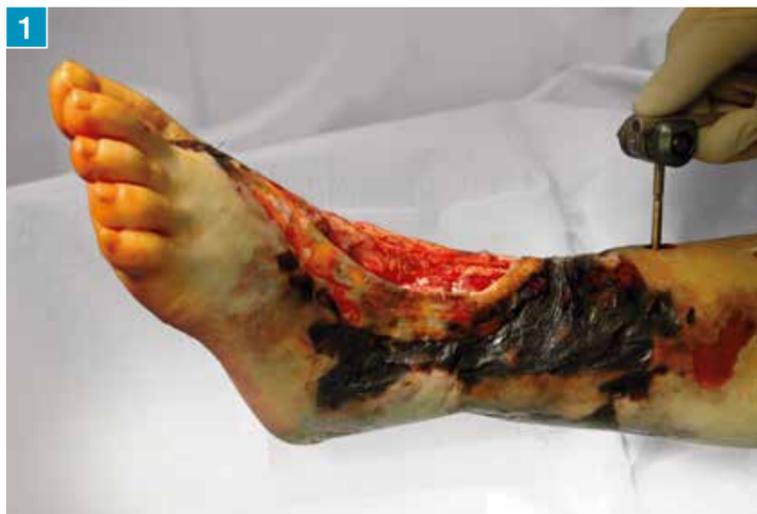
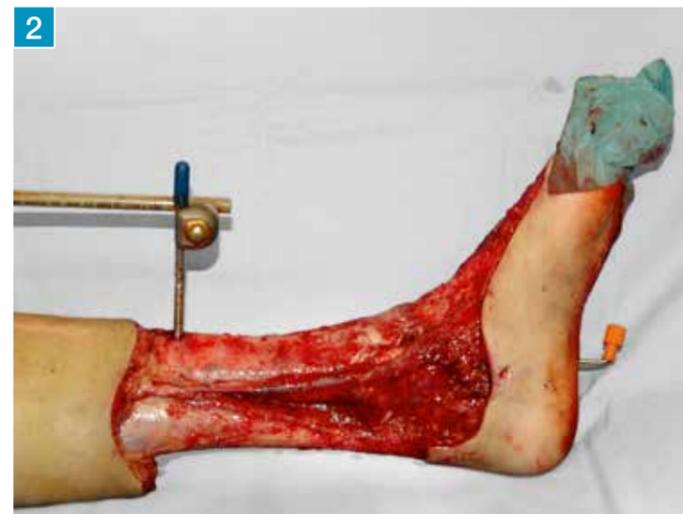
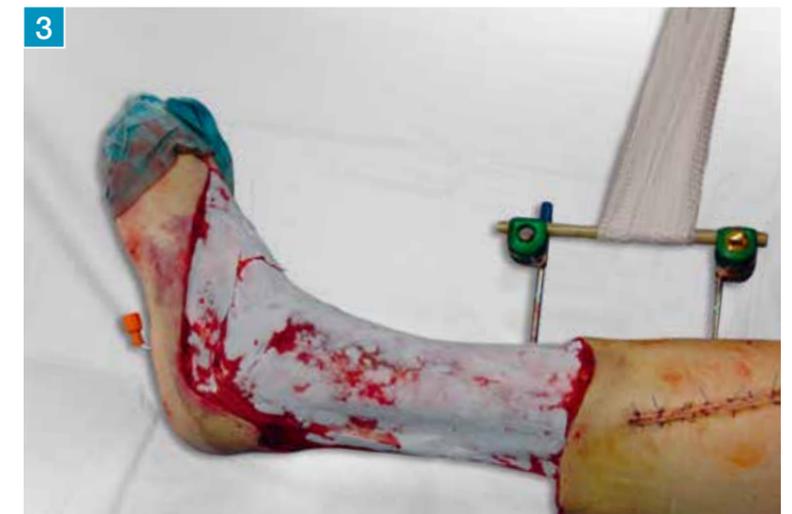
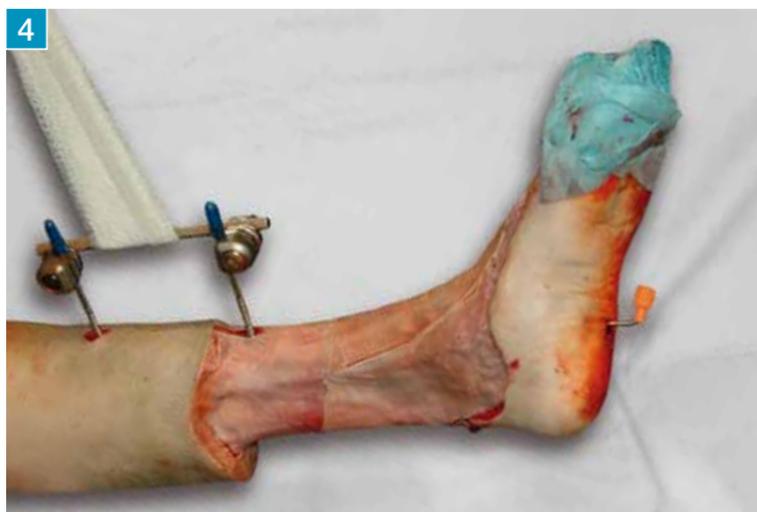
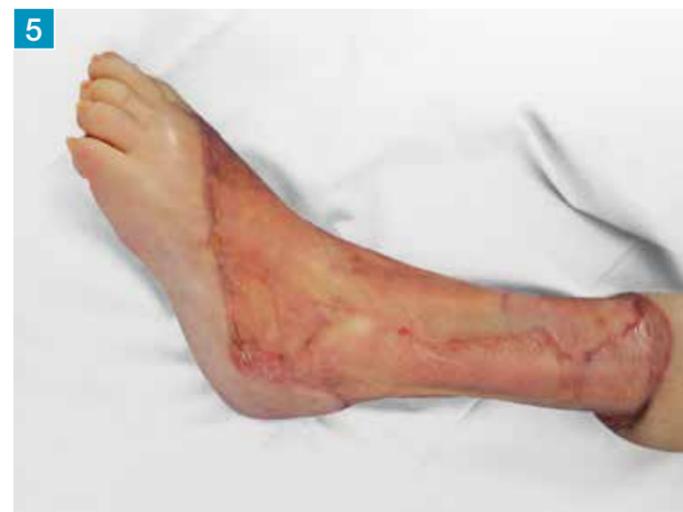
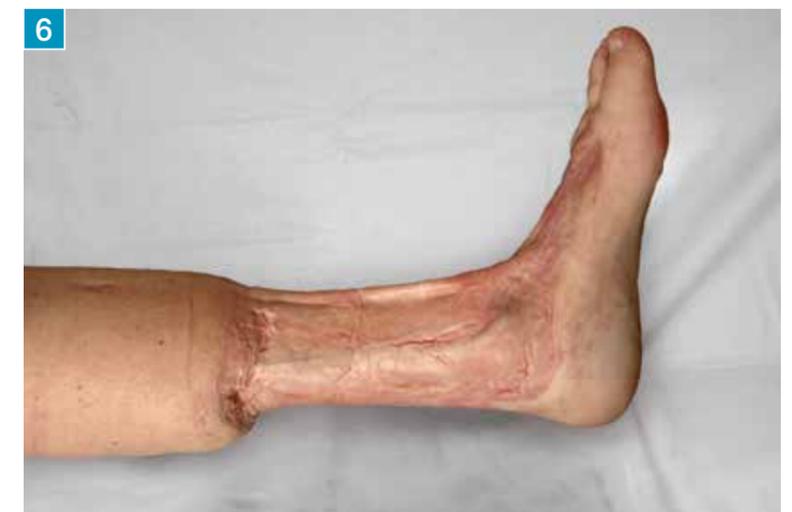
Crush trauma by a school bus

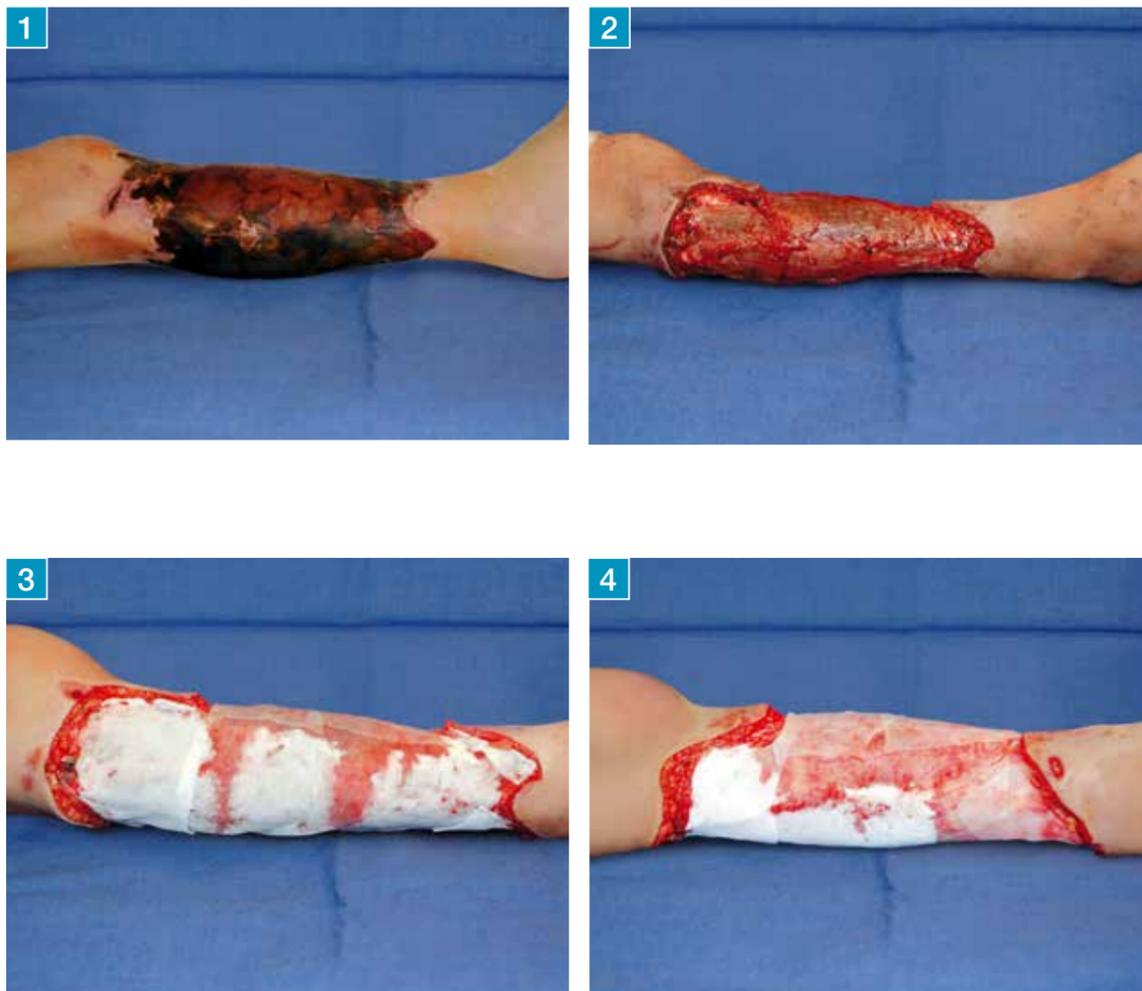
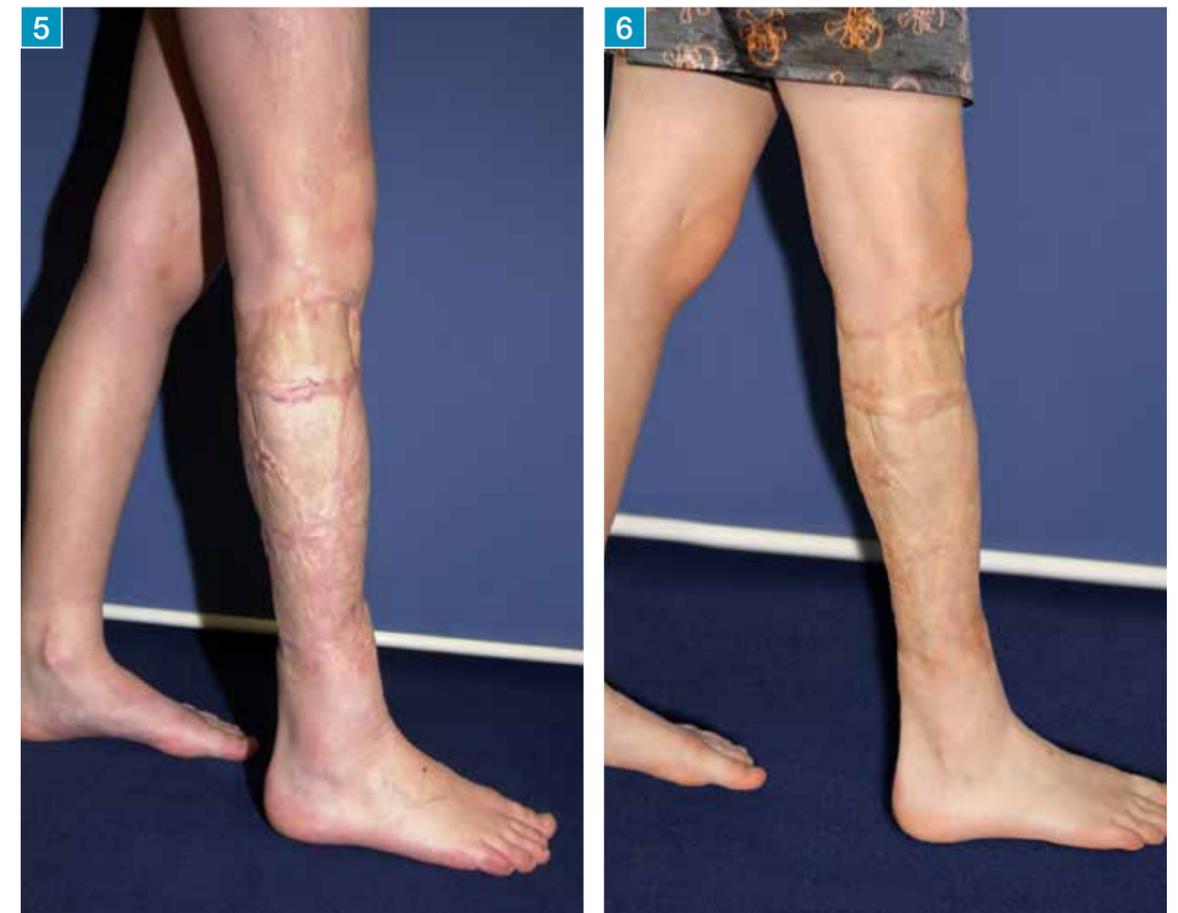
** The surgeon used MatriDerm® Dermal Matrix in a One-Step procedure. Upon the discretion of the surgeon and his/her experience with dermal substitutes the procedure and thickness of MatriDerm® Dermal Matrix can differ from the recommended pathway of the decision tree.

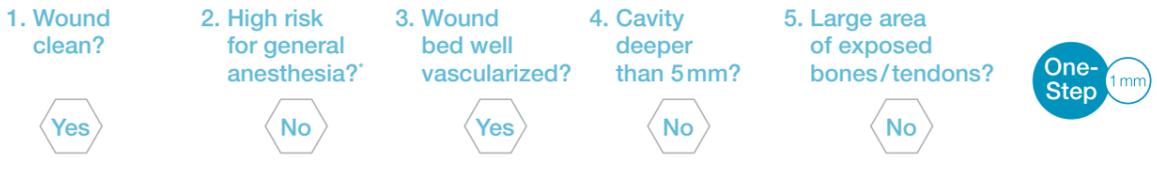
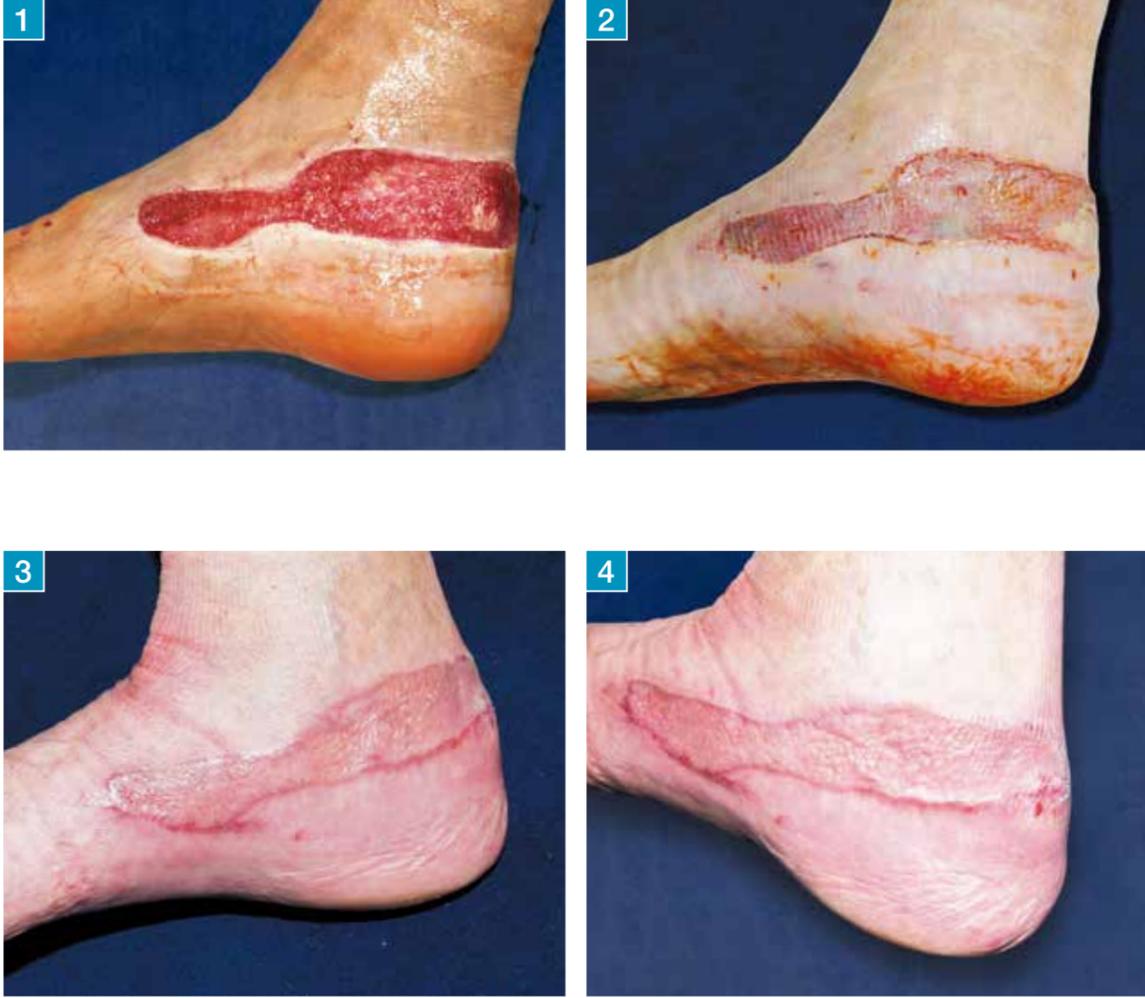
Infected dog bite at the dorsum of the hand

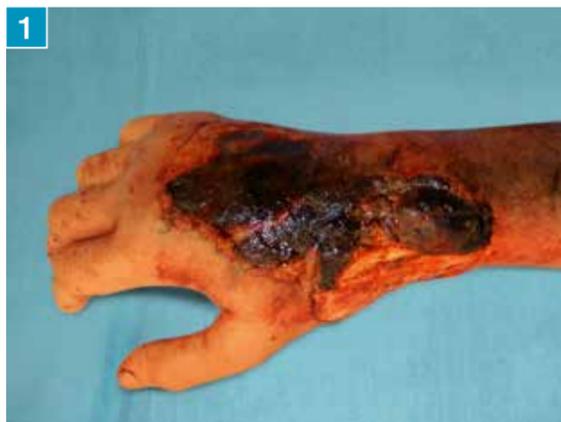
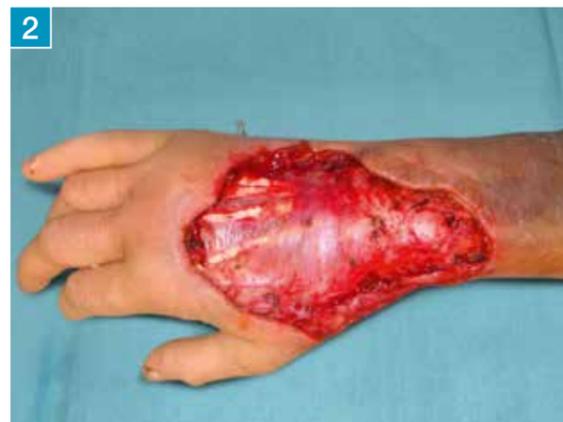
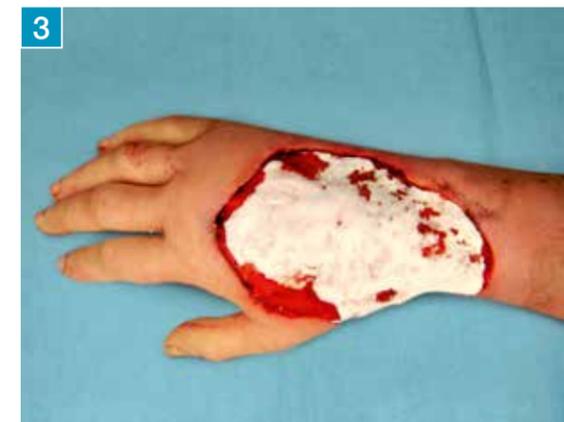
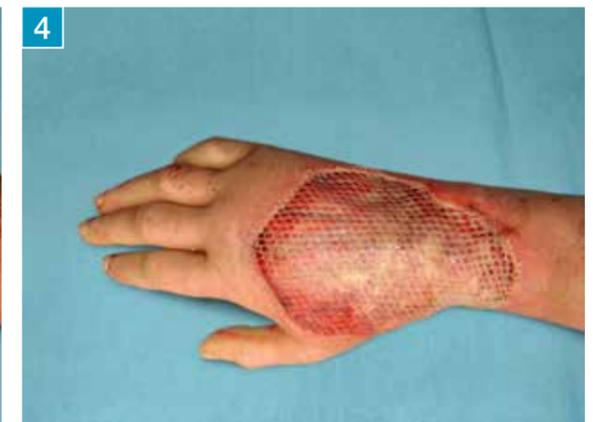
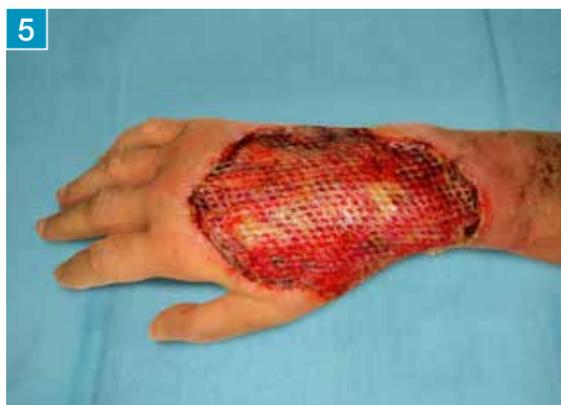
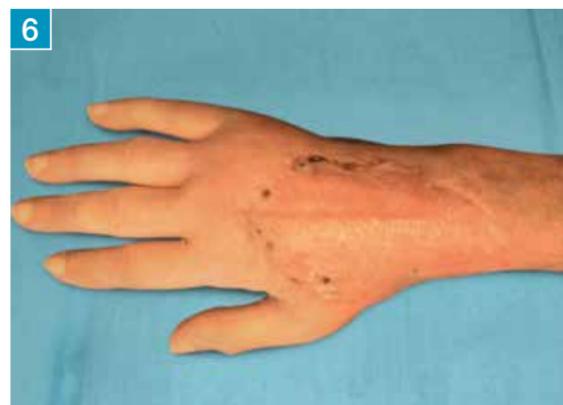
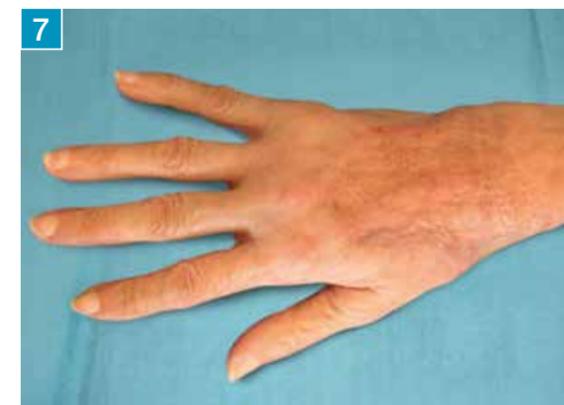
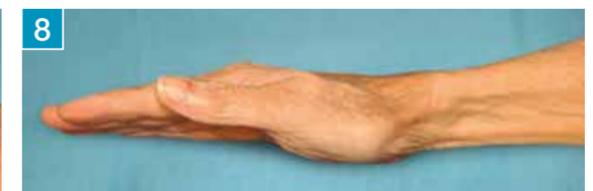
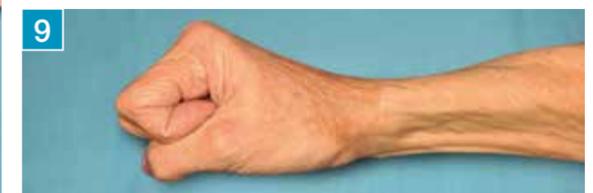
Deglovement instep and plantar regions after motor-bike injury

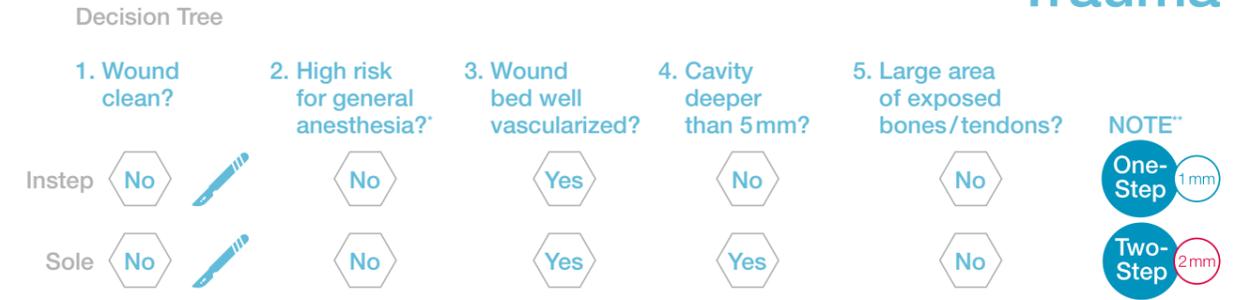
Fixation was performed with vacuum therapy for 1 week. Excellent take rate at the first dressing change (Fig. 6, 7). A small hematoma under the graft was associated with the vacuum base and can be avoided by bringing the vacuum base outside the wound area. However, this did not compromise the take. Follow-up 3 months later showed a completely healed foot with excellent elasticity of the new skin (Fig. 8).

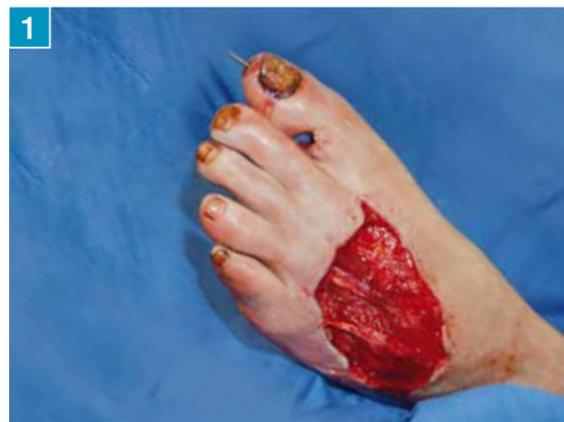
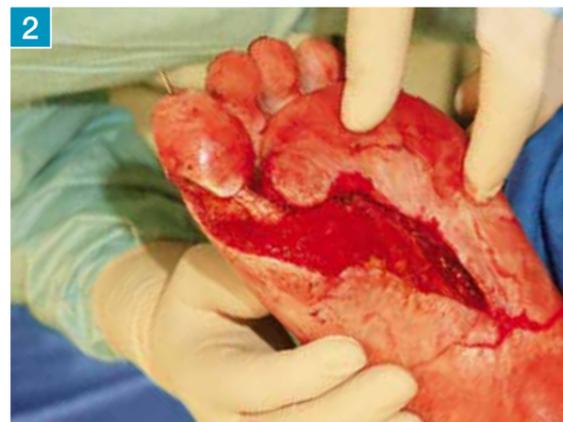
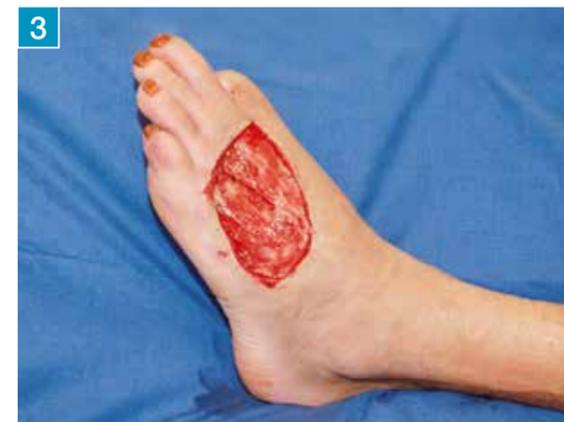
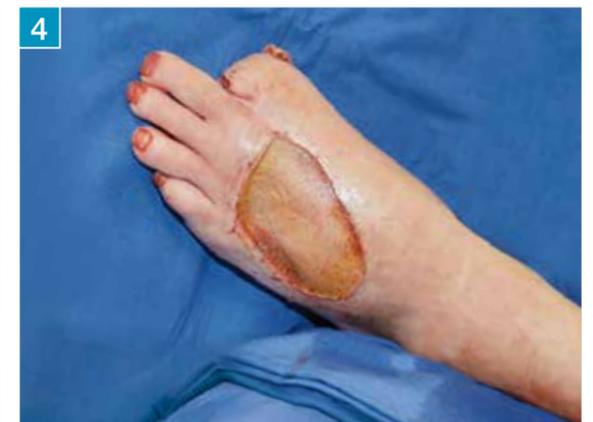
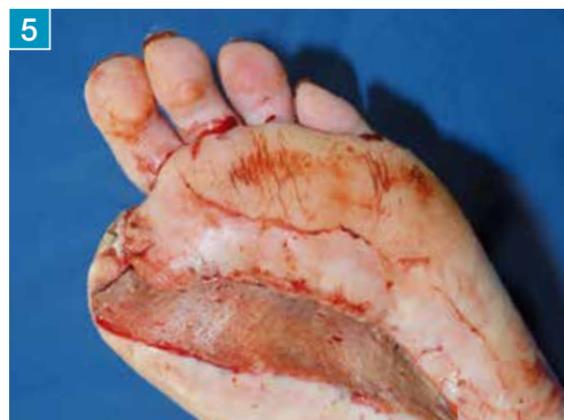
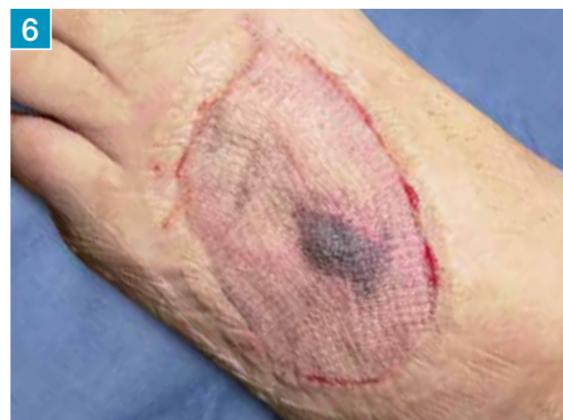
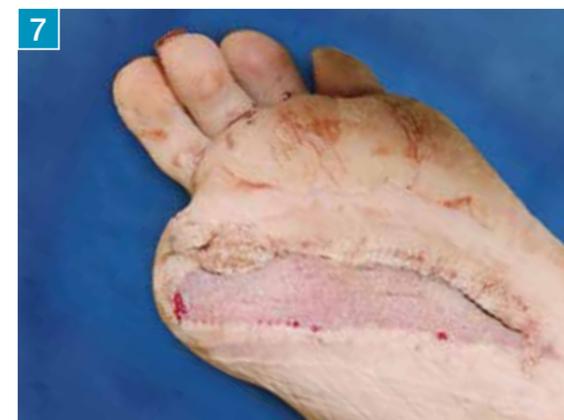
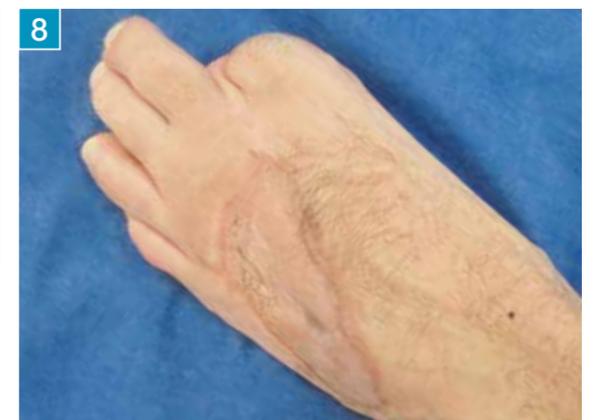
** The surgeon used MatriDerm® Dermal Matrix in a One-Step procedure. Upon the discretion of the surgeon and his/her experience with dermal substitutes the procedure and thickness of MatriDerm® Dermal Matrix can differ from the recommended pathway of the decision tree. Furthermore the surgeon performed two MatriDerm® Dermal Matrix procedures at the same time and therefore decided for a One-Step procedure for both wounds.
