Fast Regeneration
Restored Motion

Table of Contents

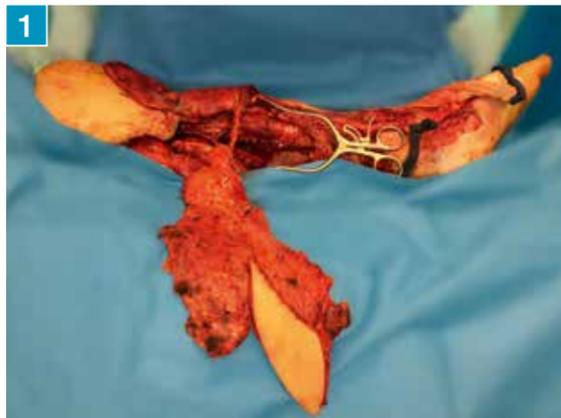
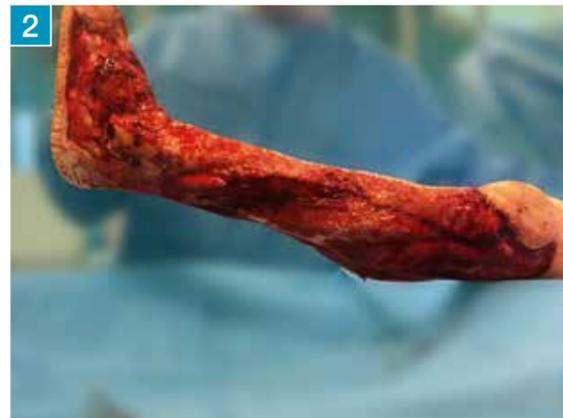
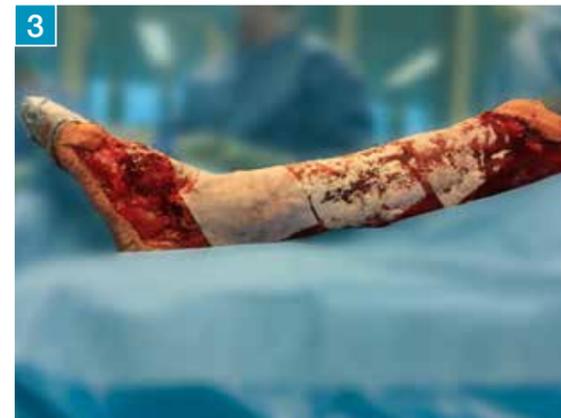
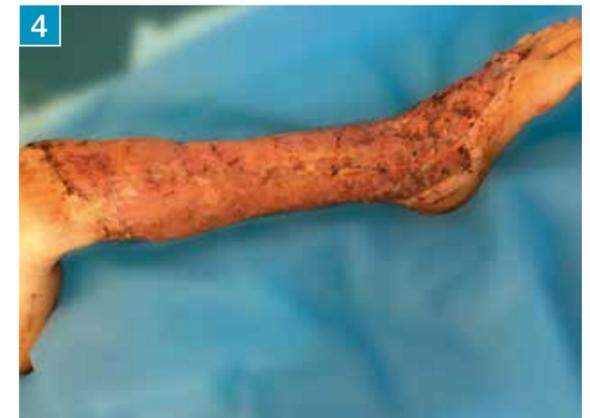
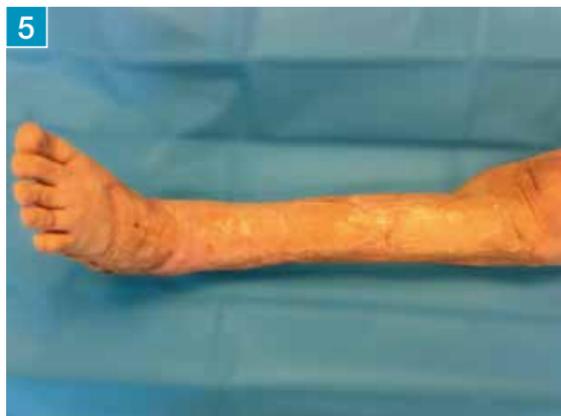
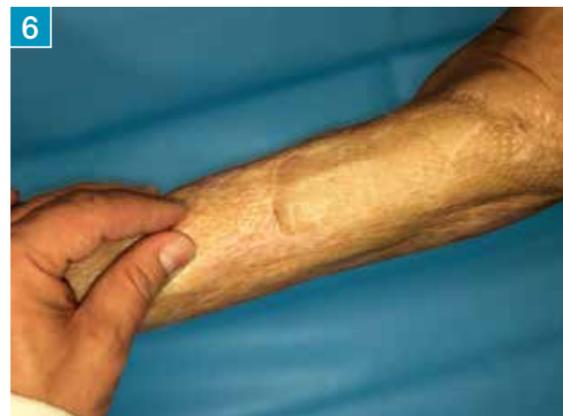
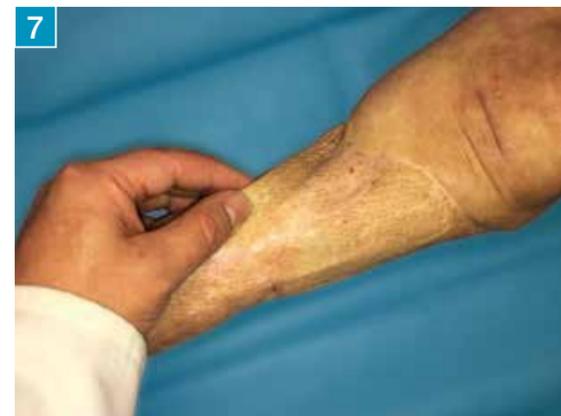
** The surgeon used MatriDerm® Dermal Matrix in a One-Step procedure. Upon the discretion of the surgeon and his/her experience with dermal substitutes the procedure and thickness of MatriDerm® Dermal Matrix can differ from the recommended pathway of the decision tree.

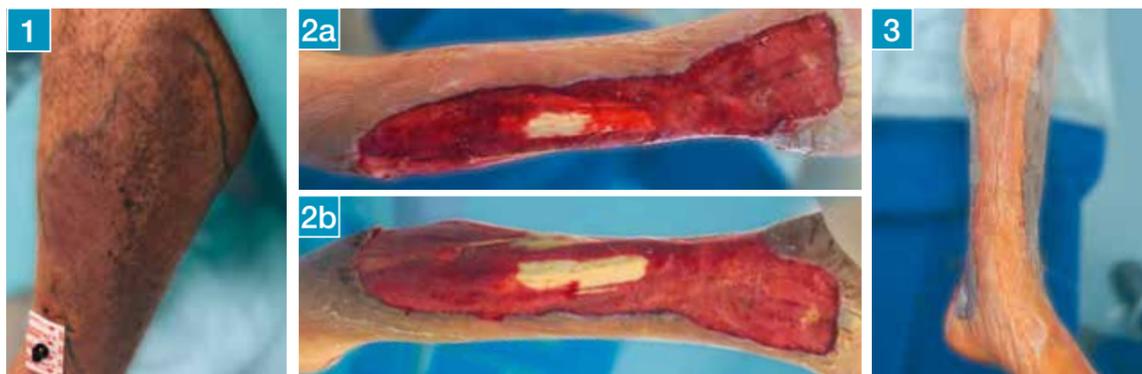
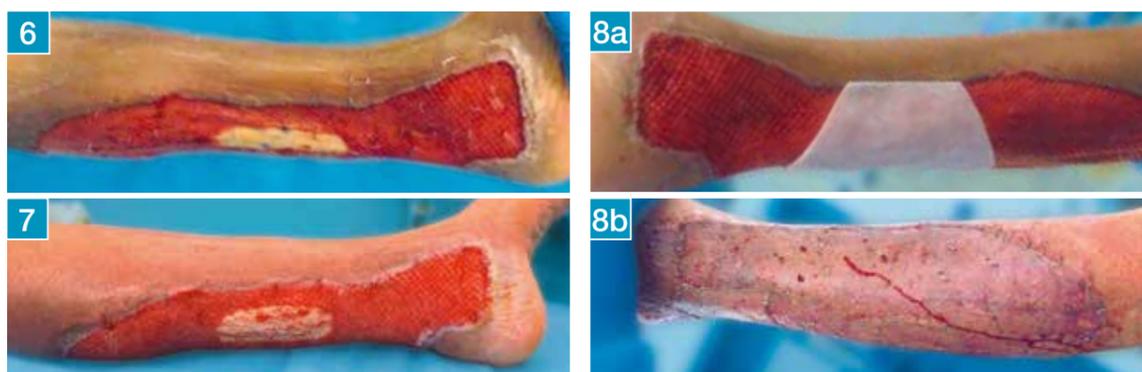
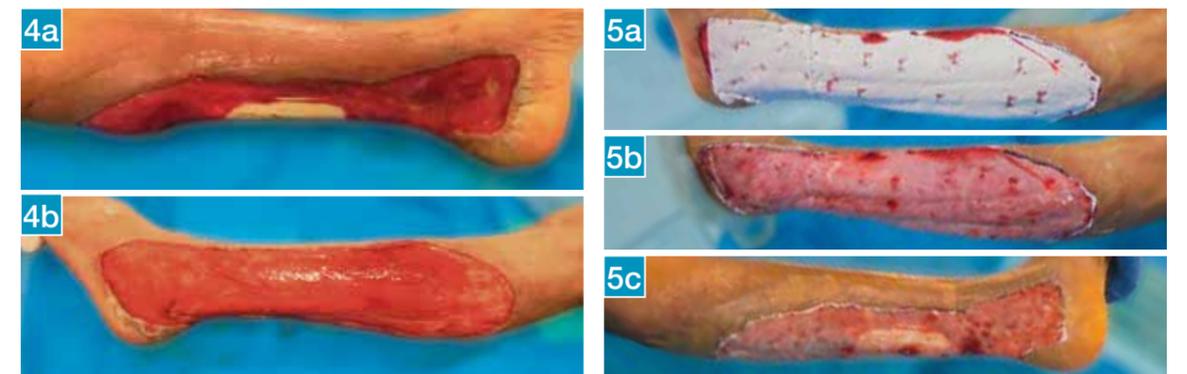
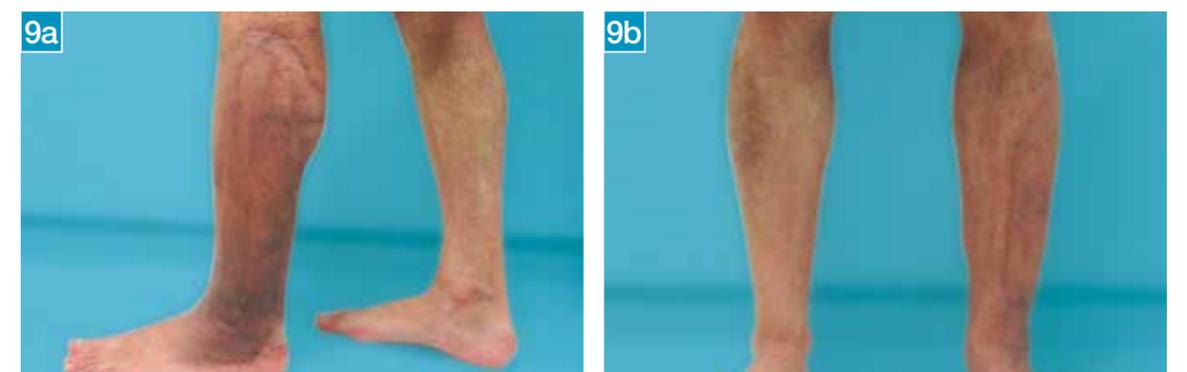
Chronic venous ulcer with 3.5 years follow-up

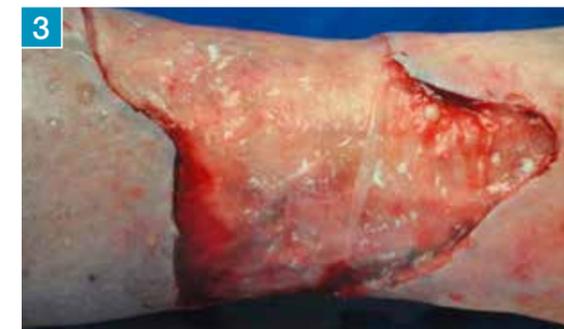
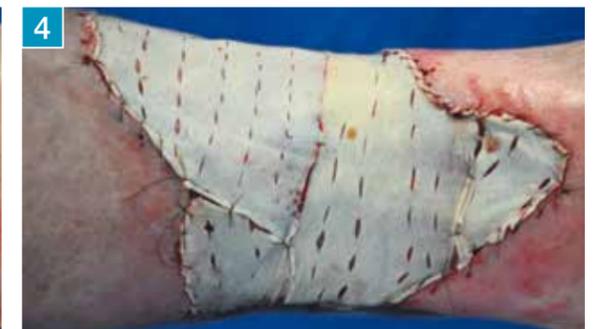
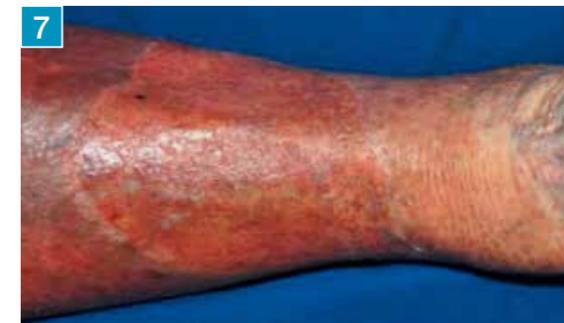
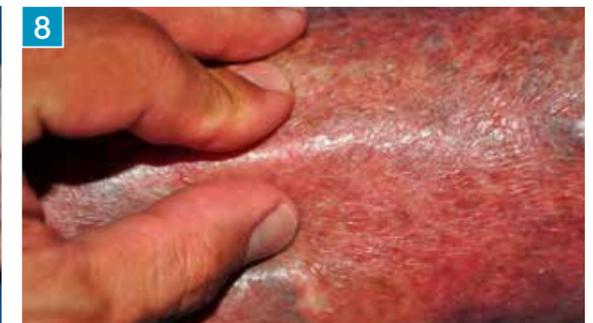
* Courtesy of F. Tostes, MD, Rio Grande do Sul, Brazil

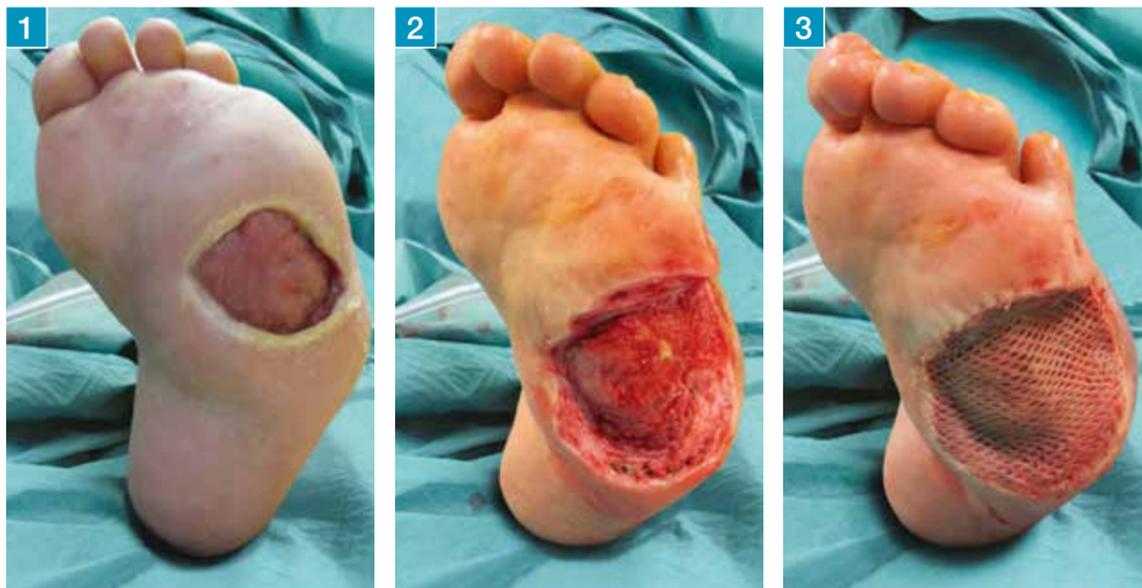
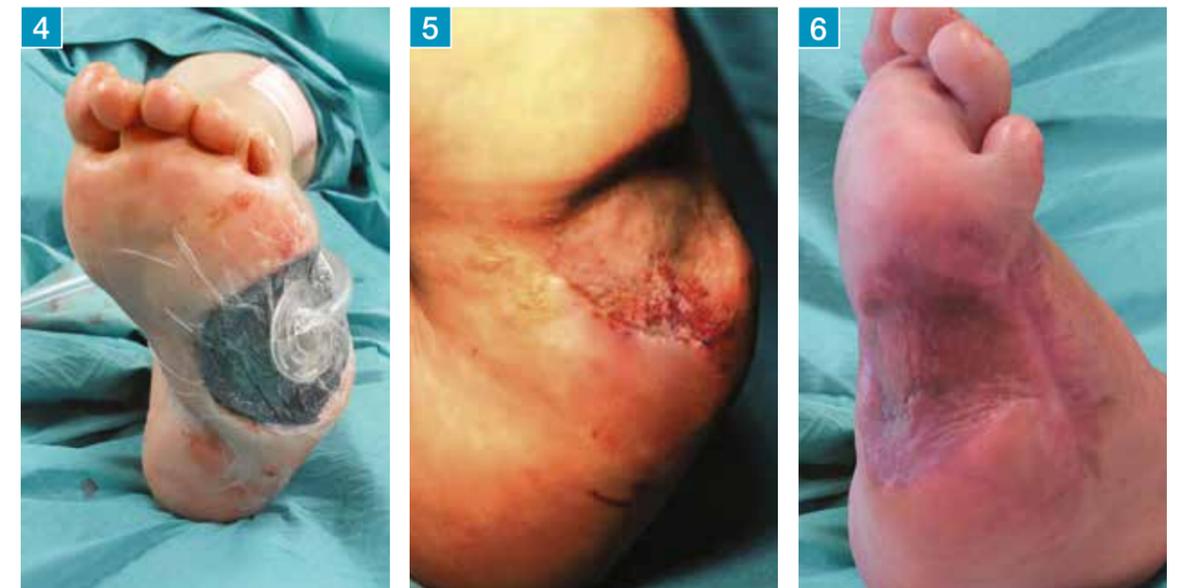
* Courtesy of H. Mössner, MD, Salzburg, Austria

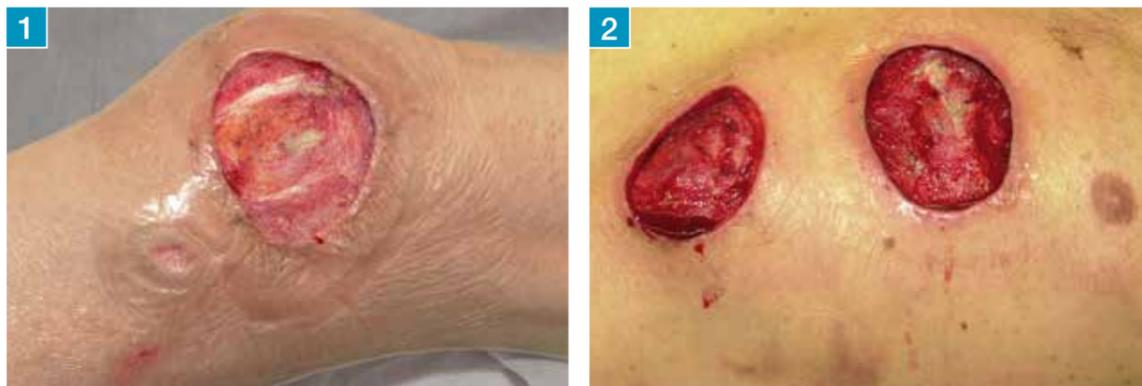
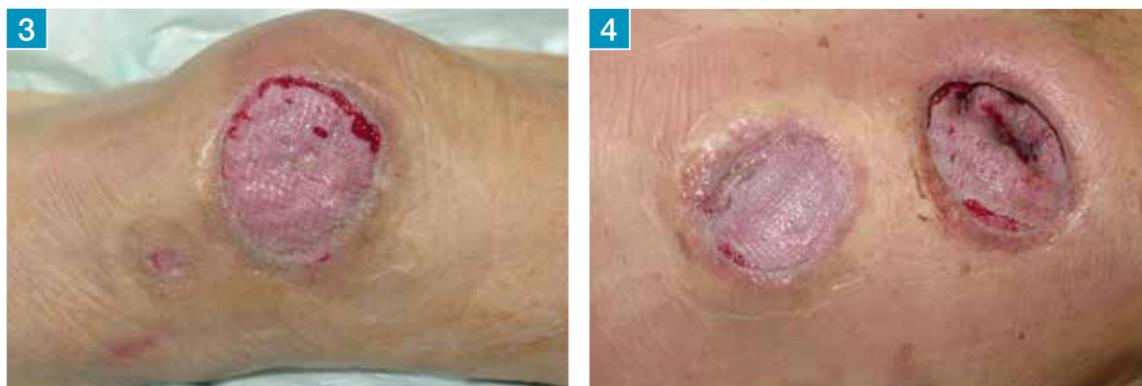
Large squamous cell carcinoma

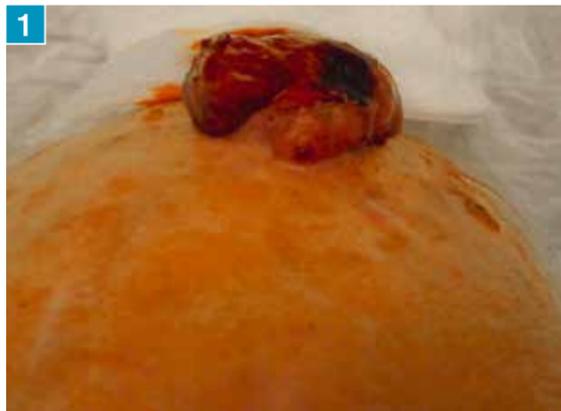
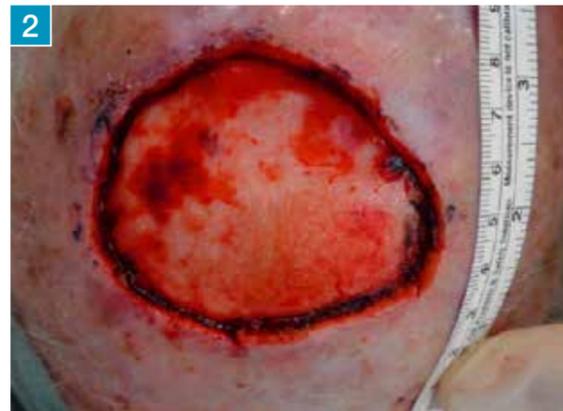
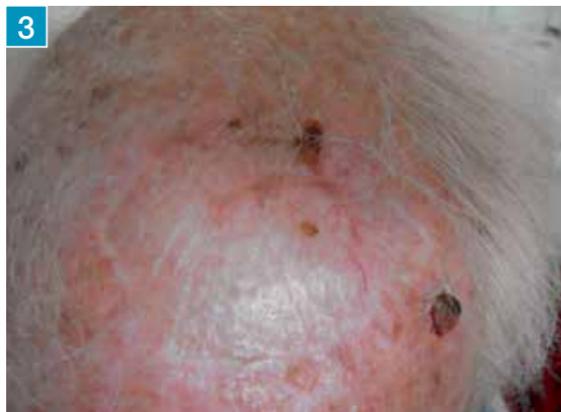
Melanoma on the nasal ridge

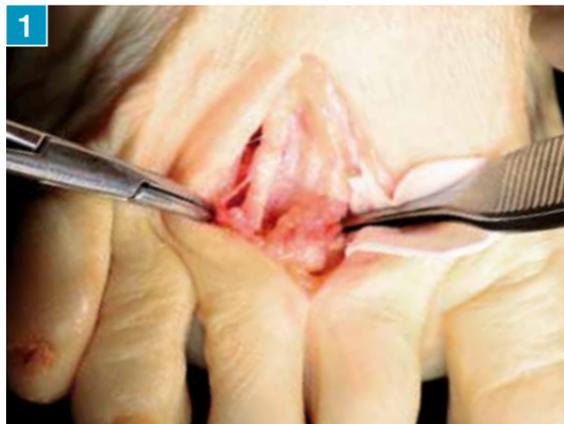
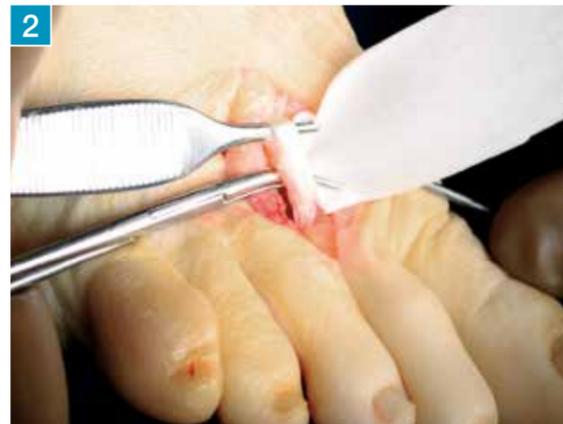
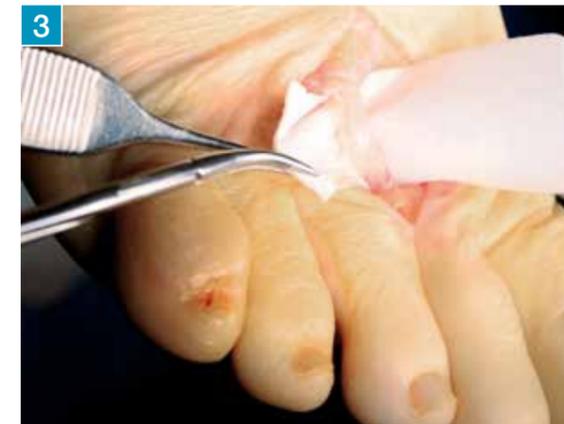
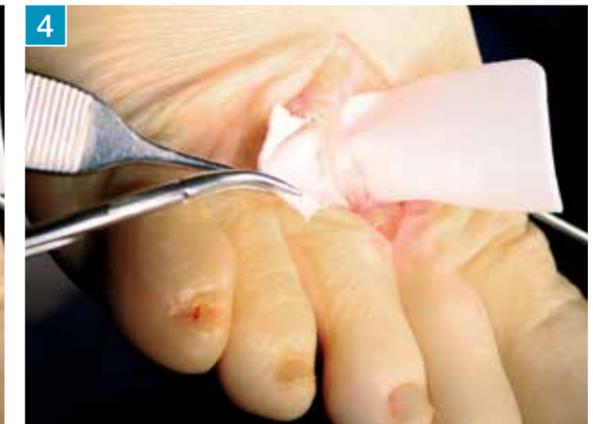
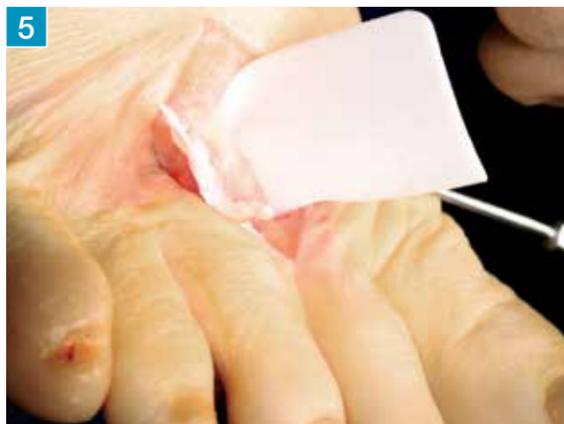
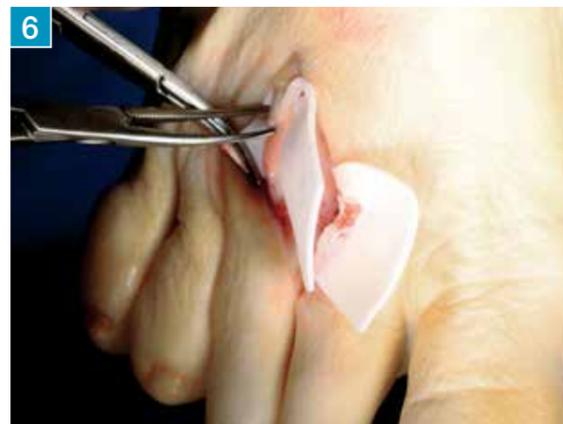
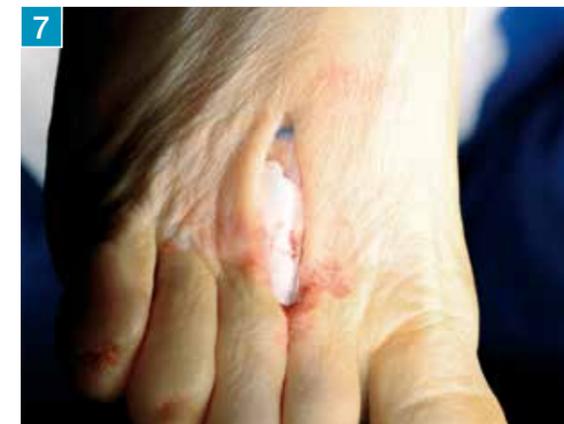
Adherent scar at knee

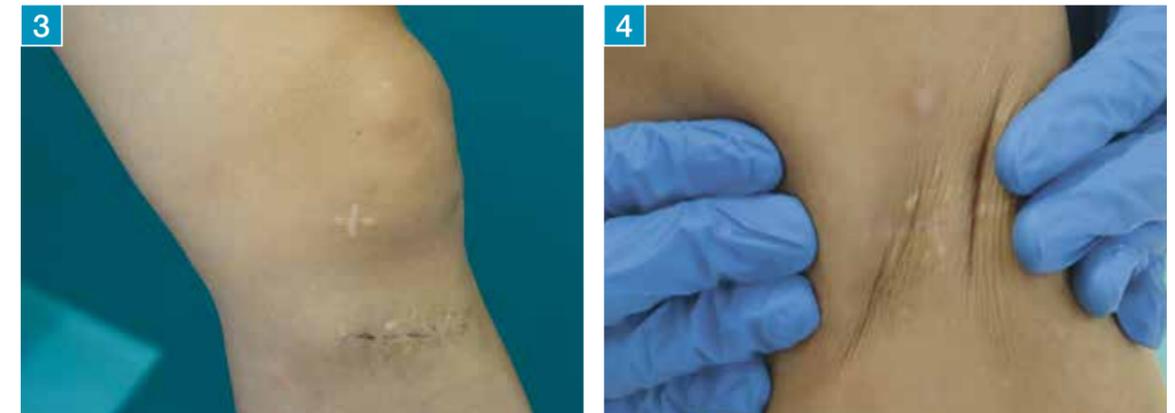
Exposed tendon of the hand

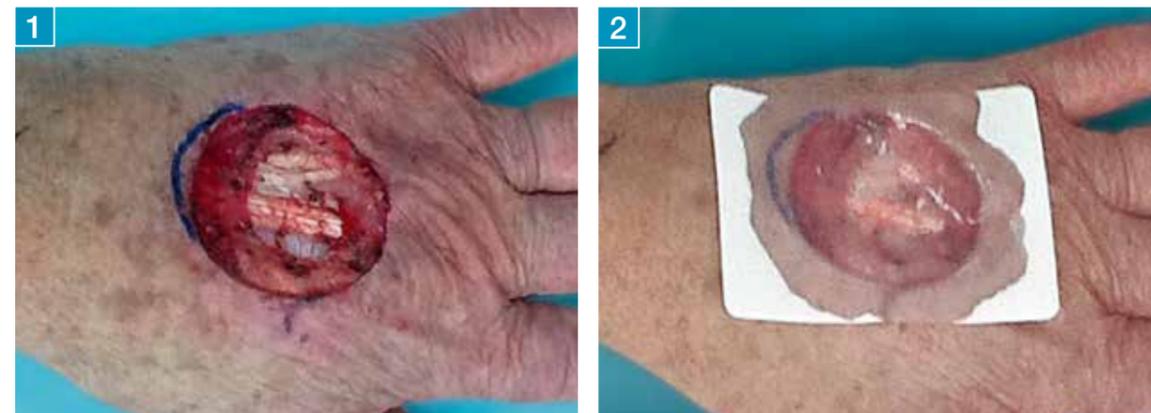
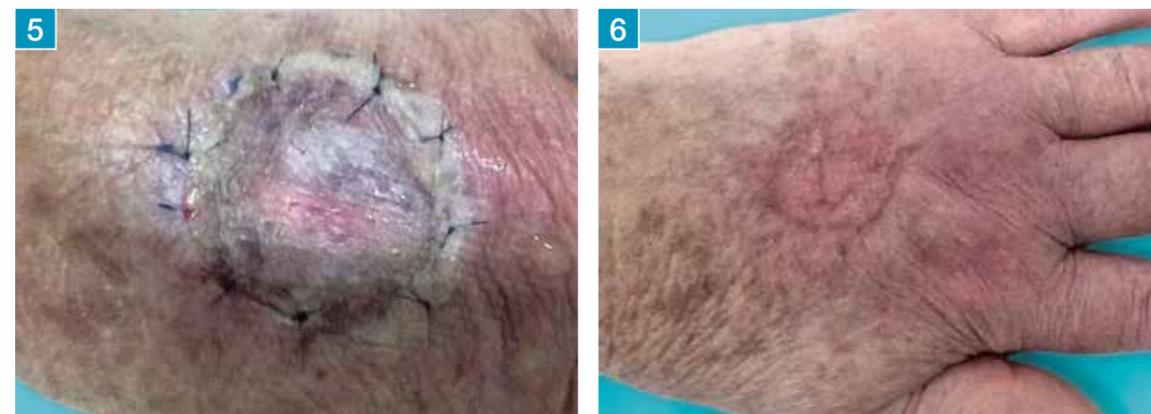
An 80-year-old patient with a history of hypertension, was referred with a suspicious lesion on the dorsum of the left hand, which was confirmed to be a squamous cell carcinoma by histopathological examination. The 2 x 2 cm tumor lesion was excised with appropriate margins. The wound bed was carefully debrided, which resulted in a defect with exposed tendons (Fig. 1). The defect was covered with a 1 mm dry sheet of MatriDerm® which was rehydrated in situ (Fig. 2). MatriDerm® was then cut to fit the wound bed with a 2 mm margin (Fig. 3). A split-thickness skin graft (STSG) was then placed on top of MatriDerm® in a One-Step Procedure (Fig 4). The STSG was fixated using sutures.
